He Pātaka Wai Ora Project

Environmental Monitoring on the Waikouaiti River

28 July 2016

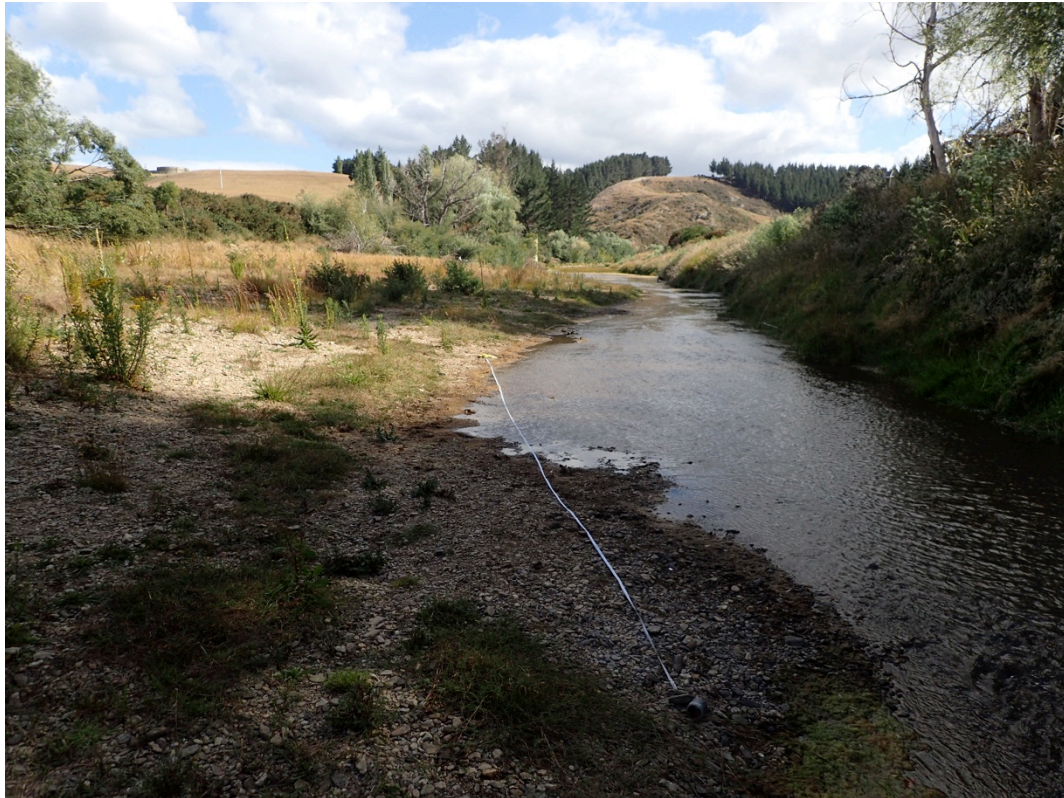
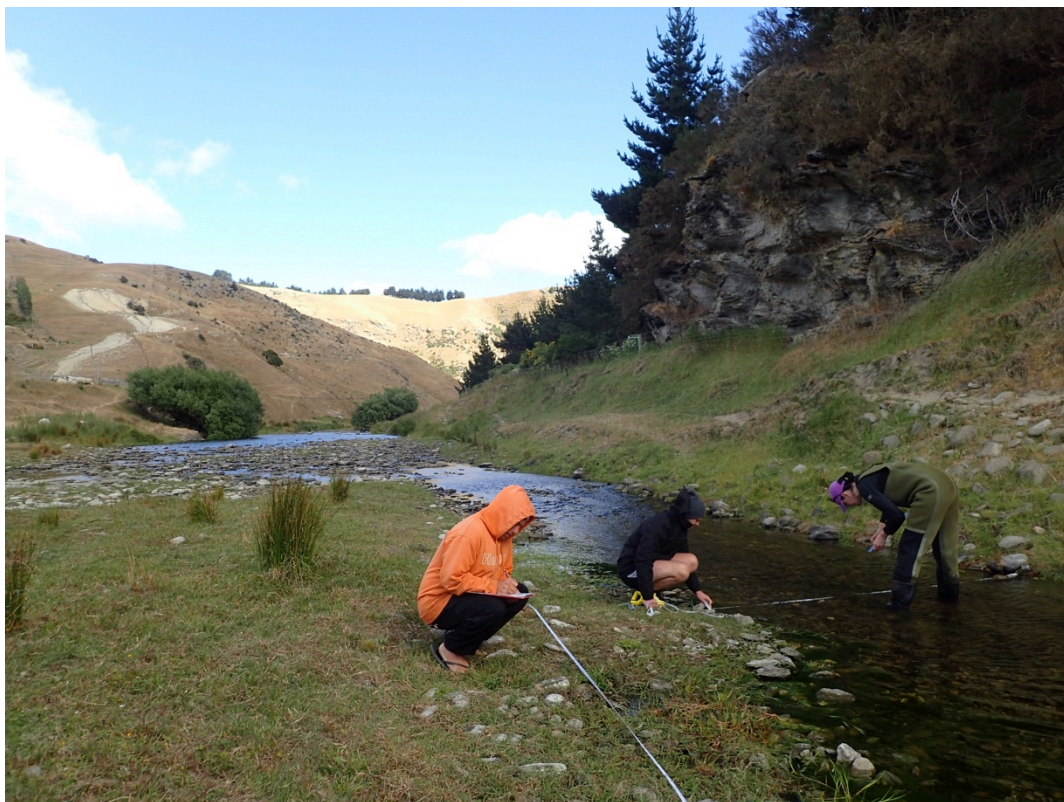
Figure 3: (Above) Ten metre transect line along the Waikouaiti River indicating the sampling area for site characteristics and the wider ecological survey. (Below) Measuring the width of the river at the upper end of the 10m transect line.

Ten-metre transects along the river, encompassing the entire width of the river, were established at each sampling site (Figure 3). Photos were taken of each site at three different points along the transect: upstream; the cross section; and downstream. The stream bed composition (substrate type), was estimated at freshwater and estuarine mahika kai sites using a modification of the ‘Wolman walk’. The surveyor walked down the 10 m strip of the river and at 10 haphazardly chosen points the substrate type was recorded. Substrate types were classified according categories defined in the SHMAK manual: bedrock, boulders (> 25 cm), large cobbles (12 – 25 cm), small cobbles (6 – 12 cm), gravels 0.2 – 6 cm), sand, mud/silt, man-made, woody debris, water plants (rooted in the stream bed; Biggs *et al.* 2002).

River width (m) and depth (mm) were measured at wadeable freshwater sites only at 0, 5 and 10 m along the transect line. Depth measurements were taken at the true left (the left side of the river when facing downstream), centre, and true right (the right side of the river when facing downstream), with width measurements taken between wetted edges (Figure 3).

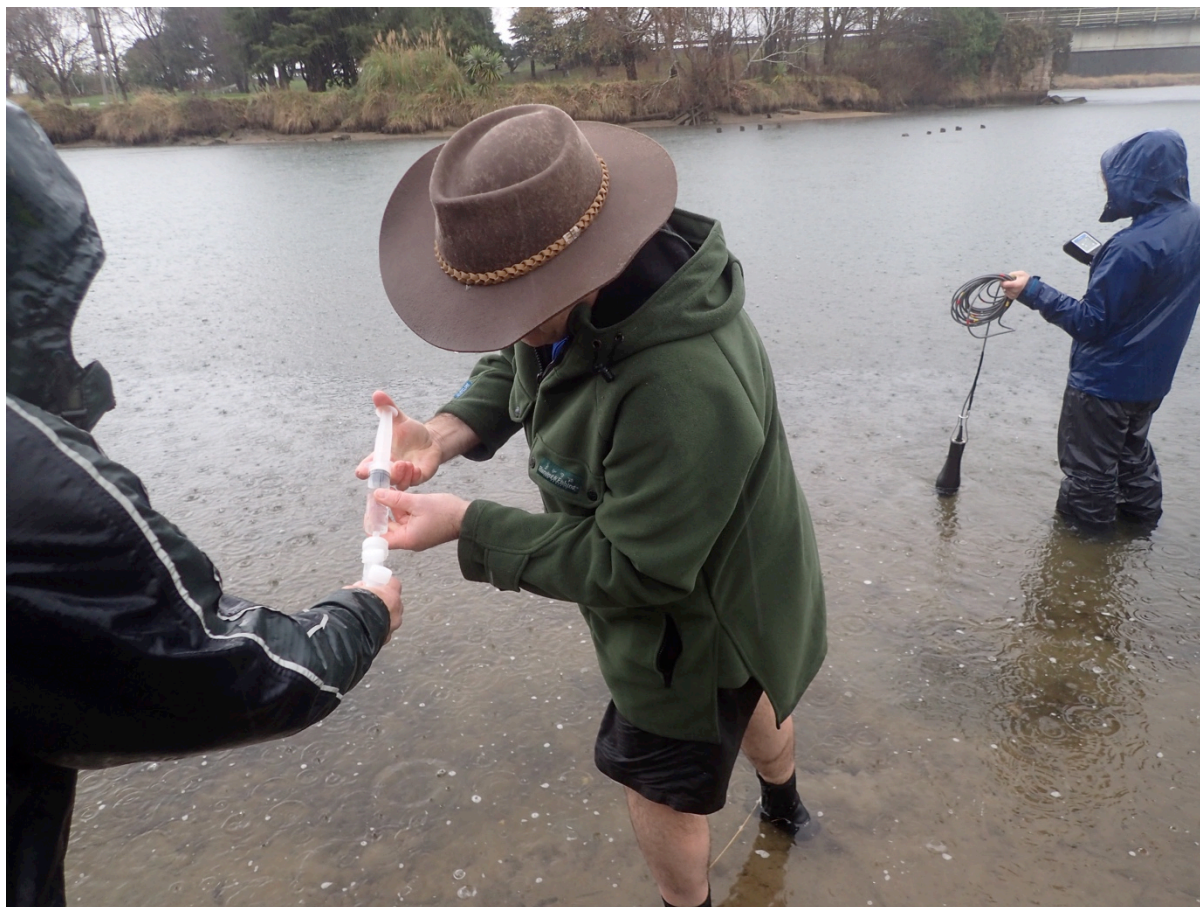
Figure 4: Taking water samples for nutrient analysis (foreground) and using a multiparameter probe to measure the physical and chemical parameters (background) within the Waikouaiti River.

At each site, three replicate water samples were taken using a Luer-lock syringe and then filtered on-site using a Whatman GF/C glass microfiber filter in a 25mm Swinnex filter holder (Figure 4). Before use, the equipment was all acid-washed (10% HCl) and prior to sampling, was rinsed with 30 ml of water from the site. The three samples were filtered into 25 ml acid-washed tubes, placed in a chilled bin with icepacks and then frozen immediately on return to the field station (<3 hours) to be analysed later at the laboratory. Analysis of water samples was done using a QuickChem 8500 Automated Ion Analyser (Lachat Instruments, Milwaukee, USA). Nutrients of interest were nitrate (NO_3^- and NO_2^-), ammonium (NH_4^+), and phosphate (PO_4^{3-}). Nutrient concentrations were reported as mg/L of Total Oxidised Nitrogen (NO_x), Ammoniacal Nitrogen (NH_4) and Dissolved Reactive

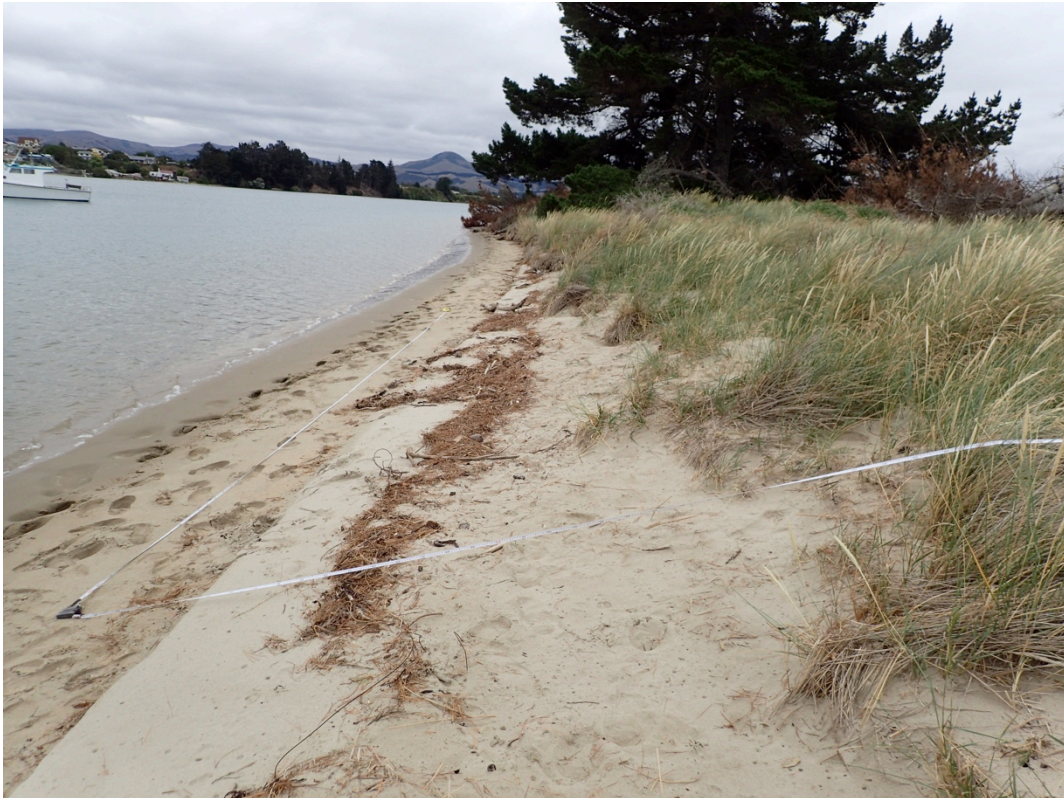
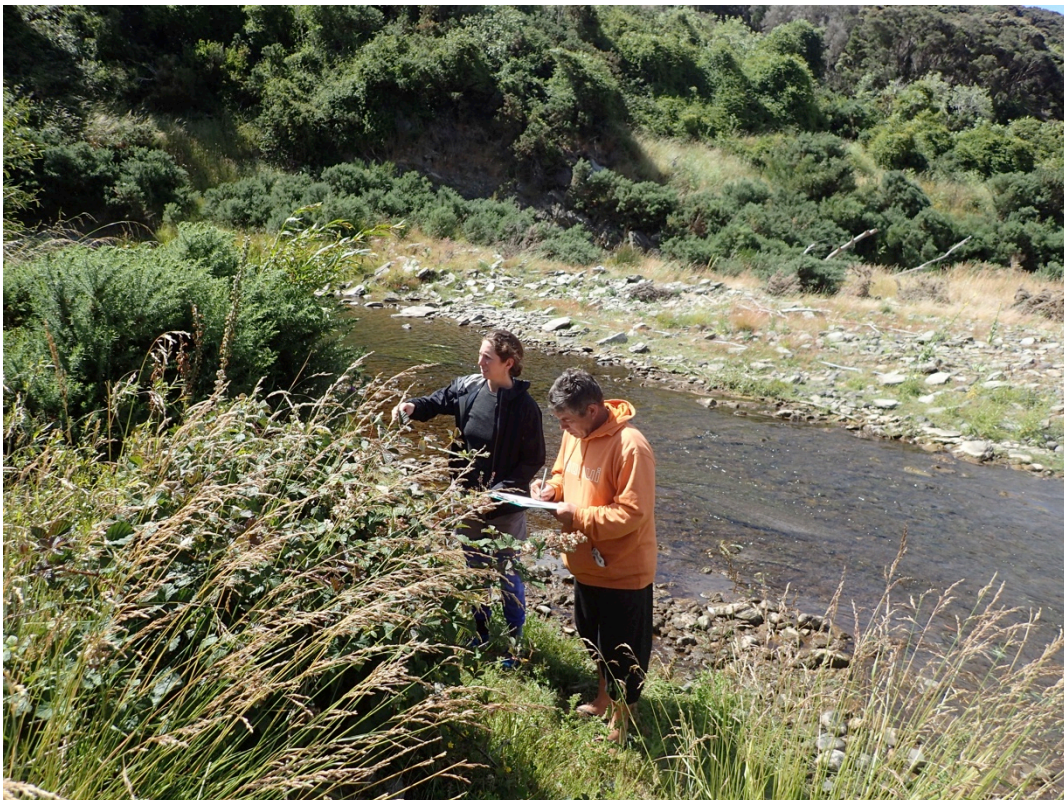
Figure 6: (Above) Riparian vegetation survey within a 10 m x 10 m area carried out along the Waikouaiti Estuary. (Below) General vegetation survey being conducted on the bank of the Waikouaiti River by Gretchen Brownstein and Brendan Flack.

The riparian vegetation survey covered the length of the 10 m transect and a 10 m wide strip of riparian vegetation (10 m x 10 m area); this area included the stream margin transect (Figure 5; Figure 6). The stream margin survey area included the length of the 10 m transect line and extended to a width of 10 cm away from the wetted edge of the river (Figure 5). The vegetation in this strip was identified to species level and percentage cover was recorded. The general visual survey was done by standing on the bank of the river, facing away from the river, within the 10 m x 10 m area where the riparian vegetation survey occurred (Figure 5; Figure 6). All vegetation, bare ground or artificial structures that could be seen were classified into percentage cover (to the nearest 5 %) of 10 categories. The categories recorded were native trees; wetland vegetation; tall tussock grassland (not improved); introduced trees (willow, polar); other introduced trees (conifer); scrub; short tussock grassland (improved); rock, gravels; pasture grasses and weeds; bare ground, roads, buildings (Biggs *et al.* 2002).

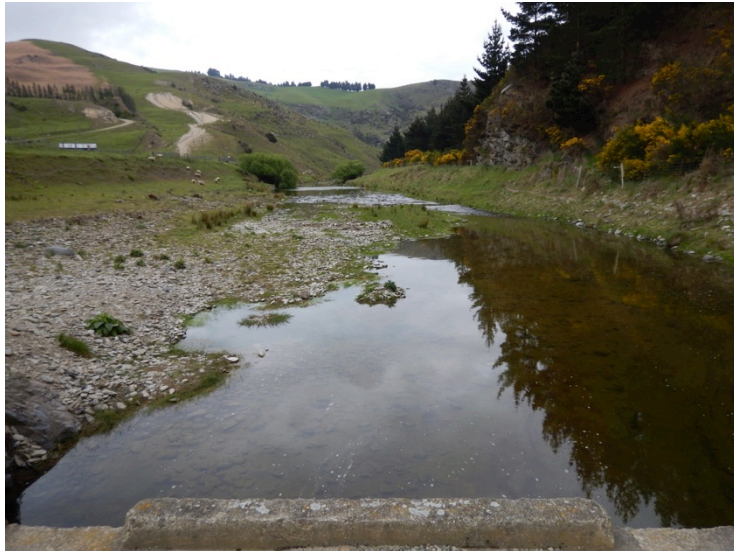
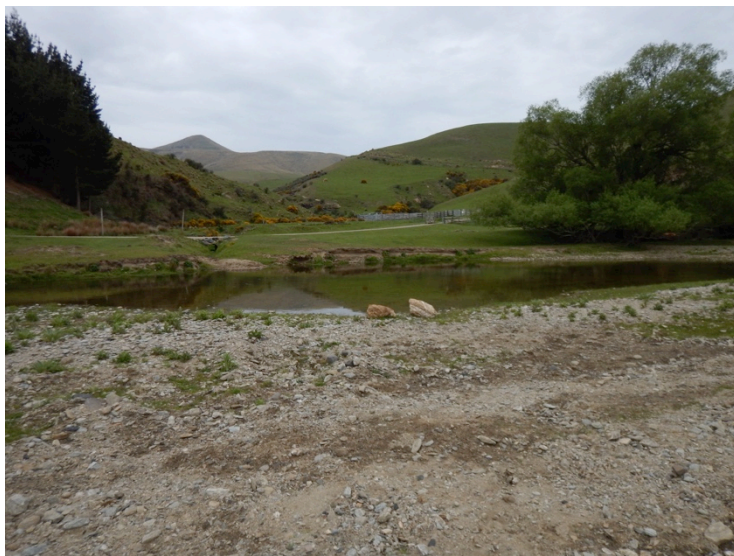
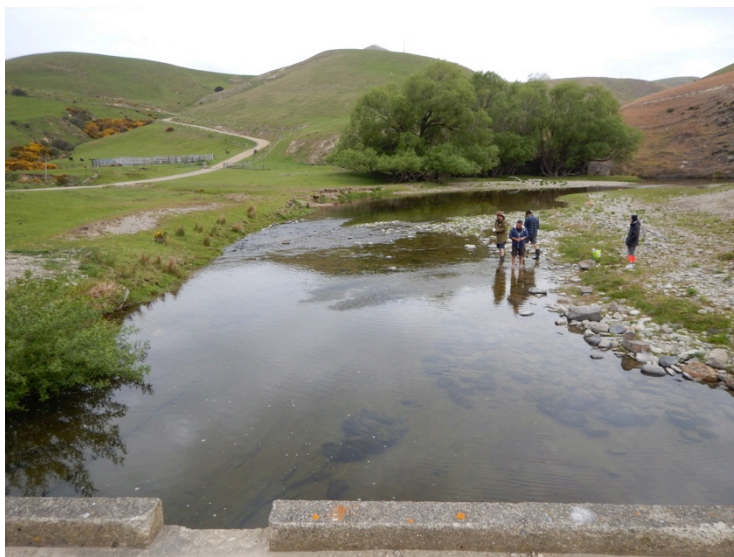
Stream Width (m)	Depth Centre (mm)	Average Depth (mm)
Downstream	5.5	251	104
Centre	3.1	110	53
Upstream	2.9	57	34

Figure 7: El Dorado (Site 1) showing an upstream (top), cross section (middle), and downstream (bottom) view.

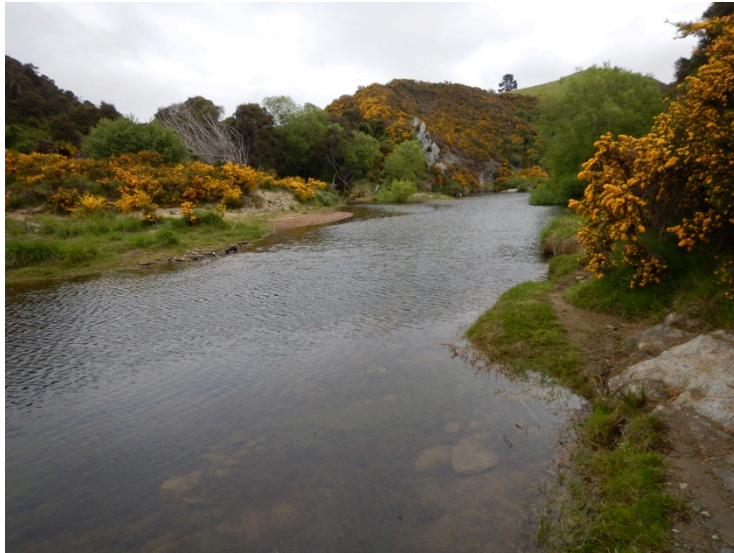
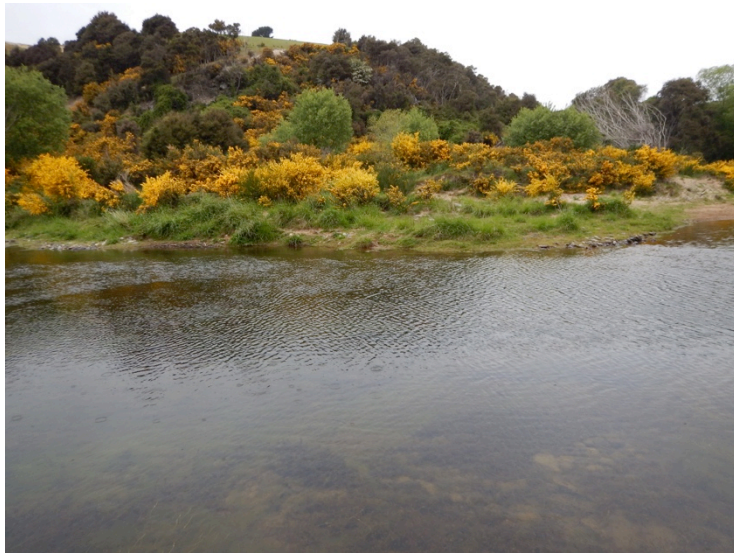
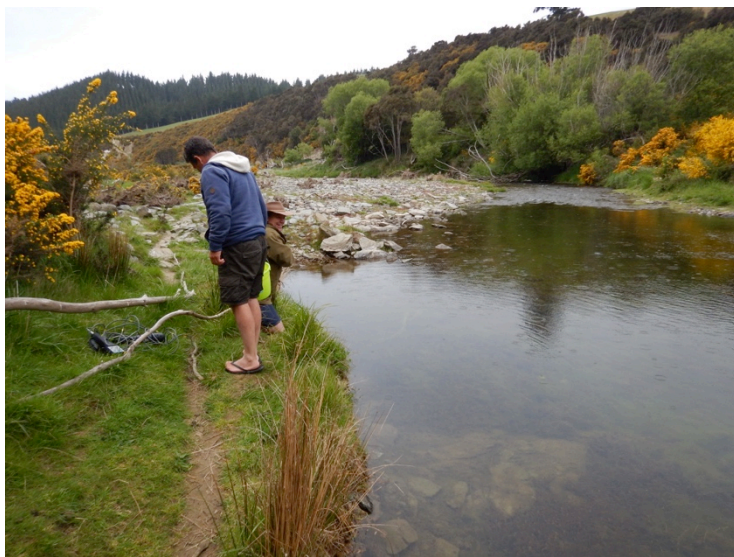
Stream Width (m)	Depth Centre (mm)	Average Depth (mm)
Downstream	7.3	120	52
Centre	6.5	170	76
Upstream	8.9	460	173

Figure 8: Hakariki (Site 2) showing an upstream (top), cross section (middle), and downstream (bottom) view.

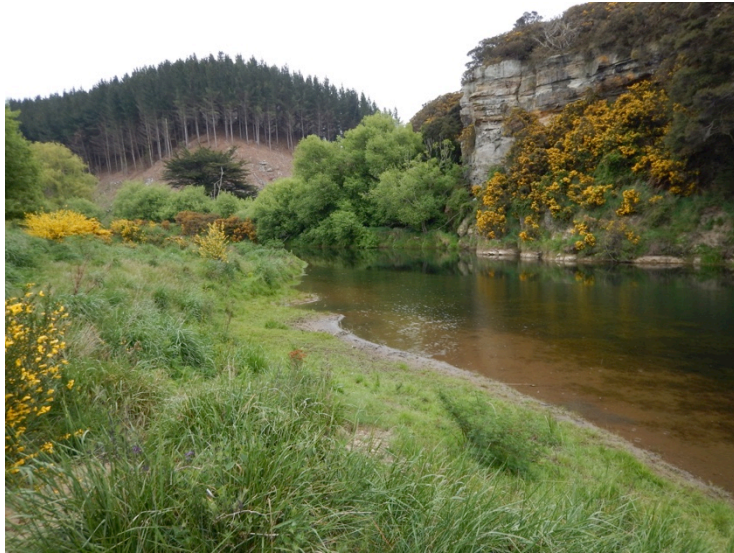
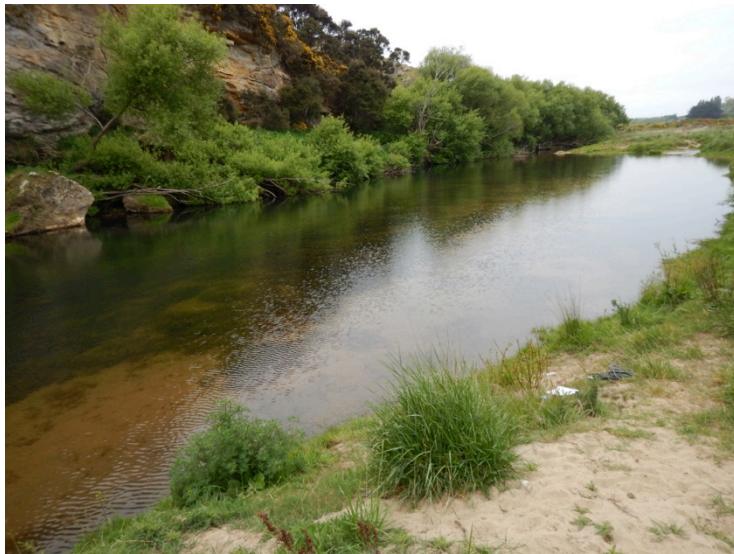
Stream Width (m)	Depth Centre (mm)	Average Depth (mm)
Downstream	4.15	53	38
Centre	6.3	115	47
Upstream	5.9	90	52

Figure 9: Te Pari Kouau (Site 3) showing an upstream (top), cross section (middle), and downstream (bottom) view.

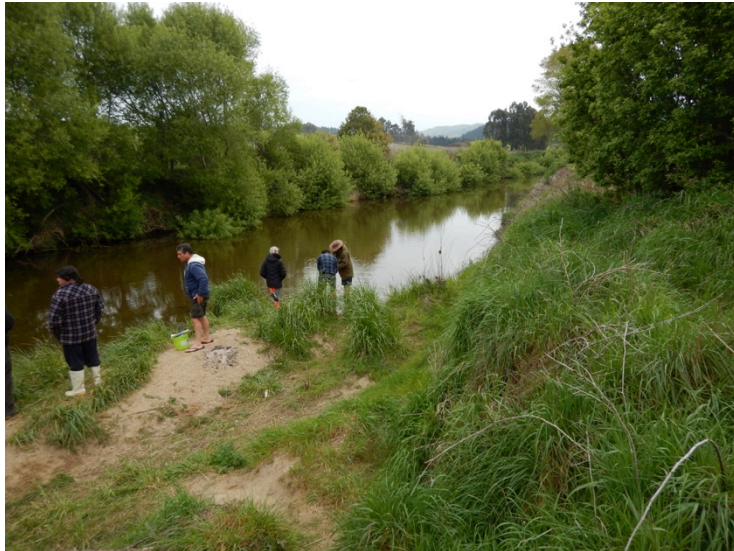
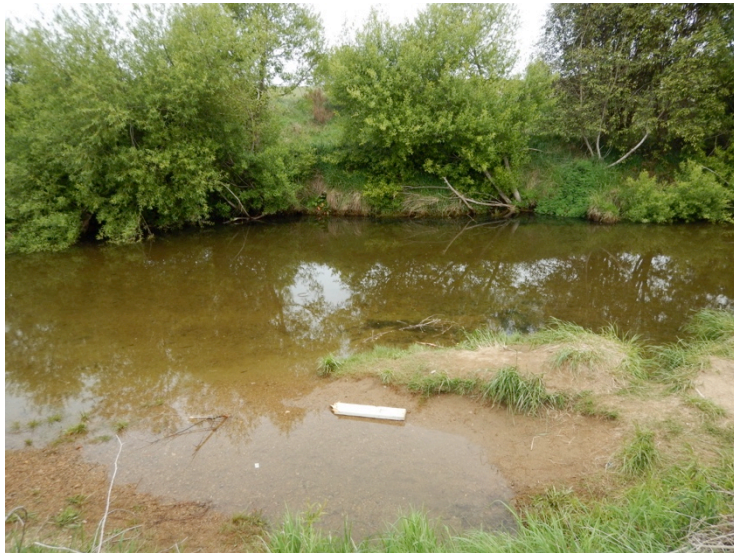
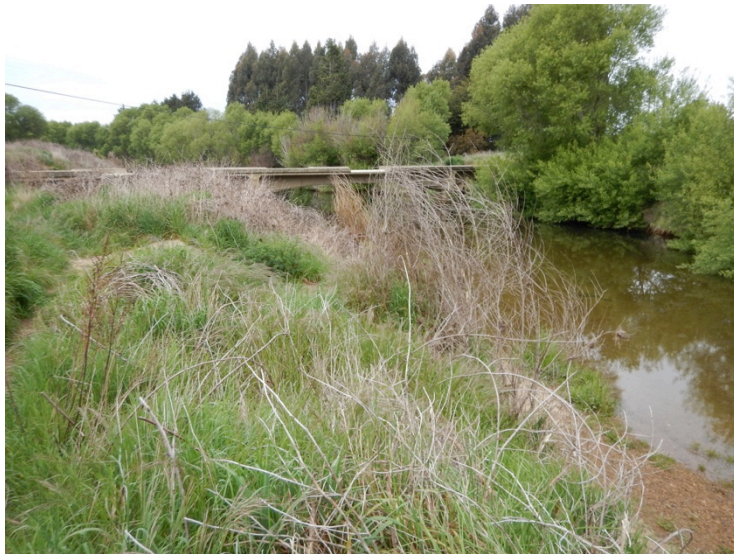
Stream Width (m)	Depth Centre (mm)	Average Depth (mm)
Downstream	14.8	200	143
Centre	13.1	195	69
Upstream	14.3	184	75

Figure 10: Whakapatukutu (Site 4), also called Orbell's Crossing, showing an upstream (top), cross section (middle), and downstream (bottom) view.

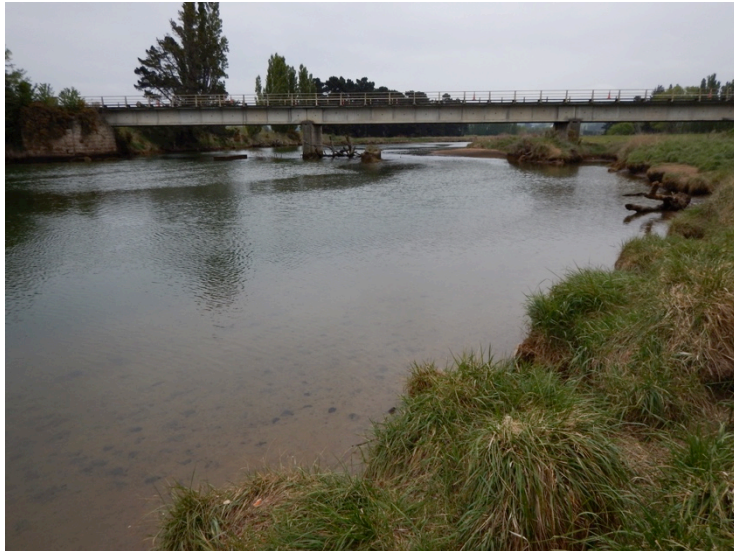
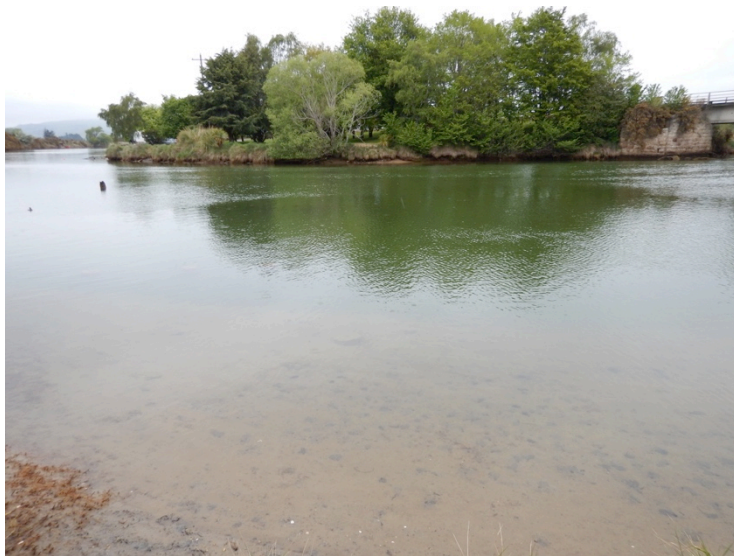
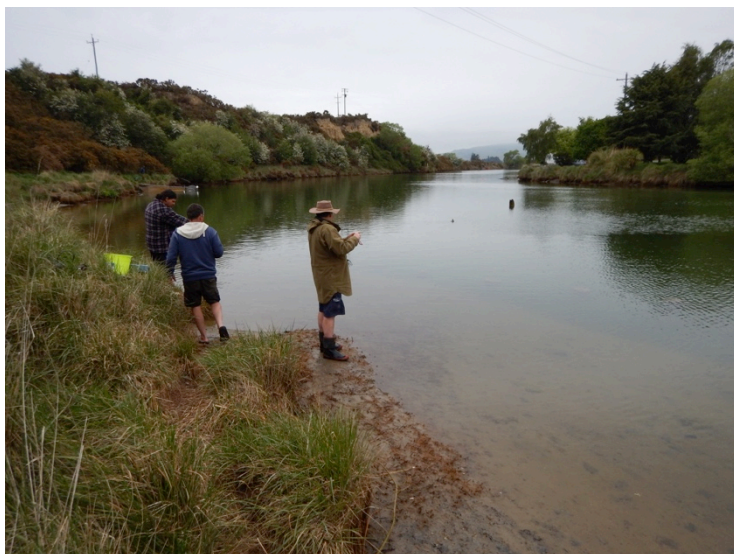
[0] Not Present
Site notes (Vegetation)	There was a park on the true right, therefore, no 10x10m survey was done on this side of the river.
Site notes (Man-made modifications)	There was a highway bridge 50m upstream from the site.

Figure 11: Okauia (Site 5) showing an upstream (top), cross section (middle), and downstream (bottom) view.

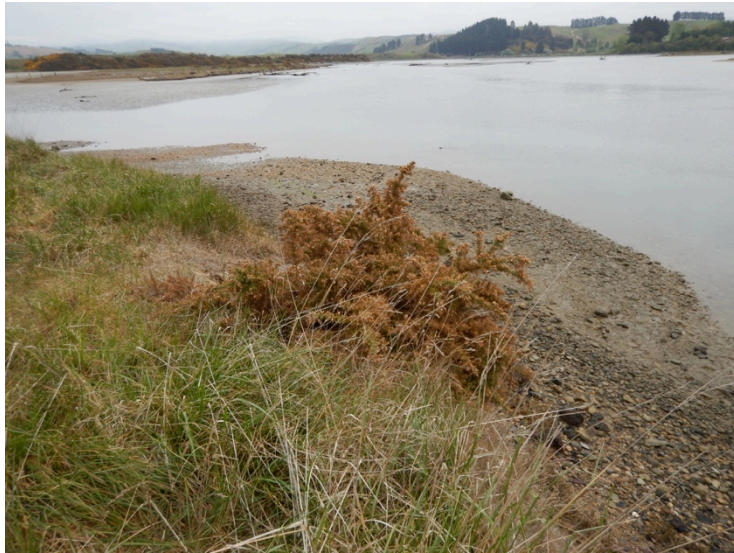
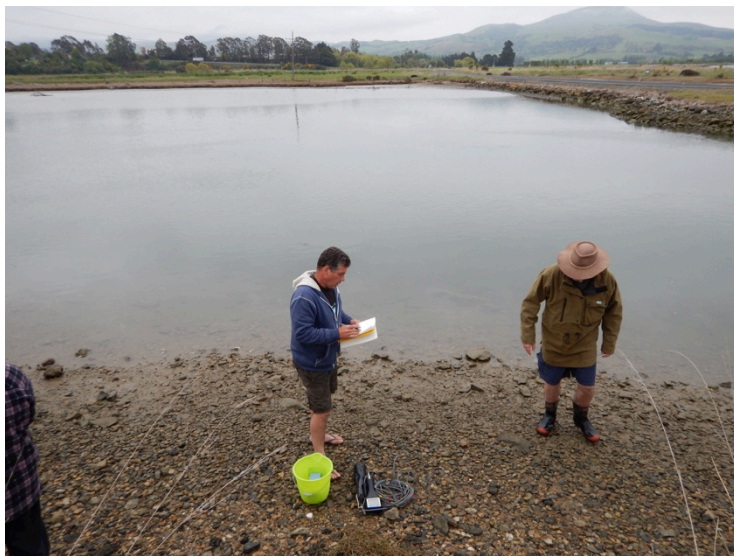
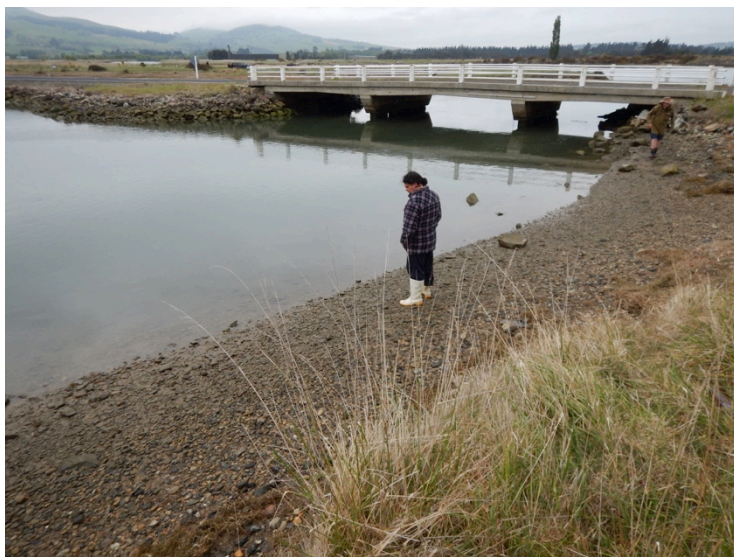
[0] Not Present
Site notes (Man-made modifications)	There was a railway bridge and a road within 50m of the site.

Figure 12: Te Tauraka a Waka (Site 6), also known as the Waka landing site, showing an upstream (top), cross section (middle), and downstream (bottom) view.

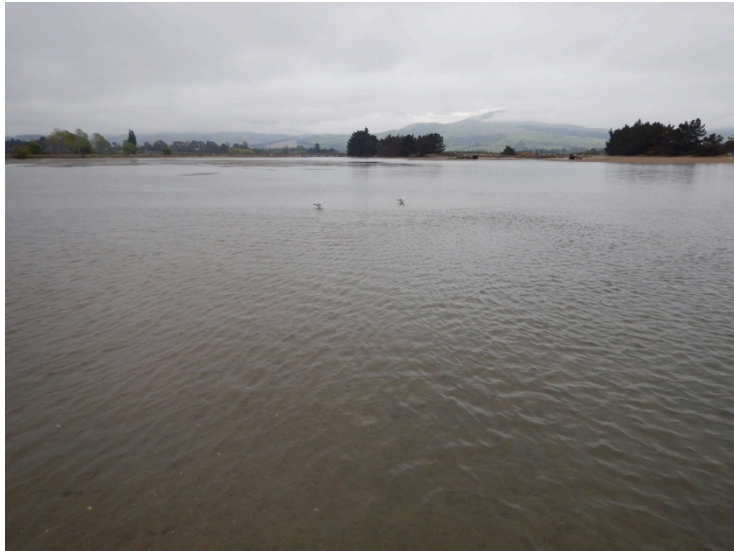
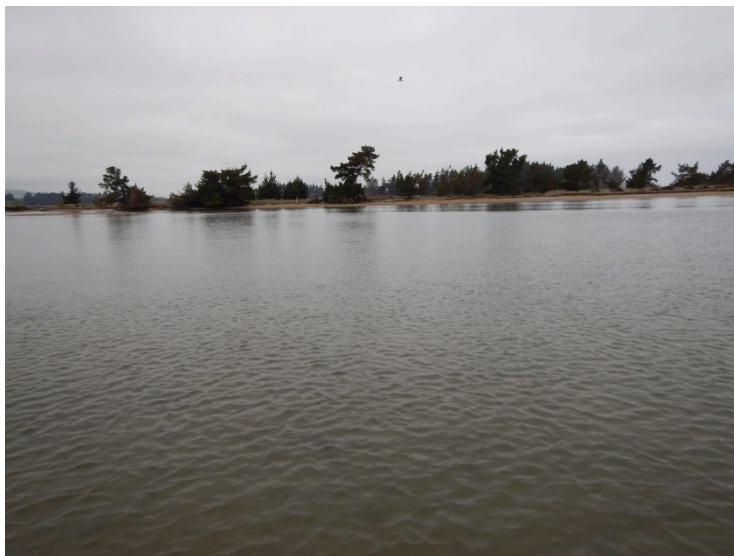
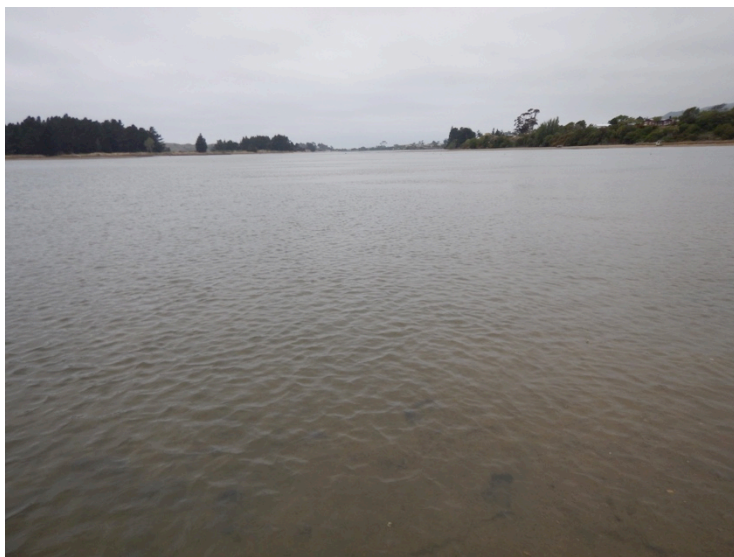
[0] Not Present
Site notes (Vegetation)	There were car tracks on both sides of the saltmarsh and floodgates on the true right going under the road.
Site notes (Man-made modifications)	There was road 100m away. A berm (raised bank) ran from the north to south of the site.

Figure 13: Te Taumata a Puaka (Site 7) showing an upstream (top), cross section (middle), and downstream (bottom) view.

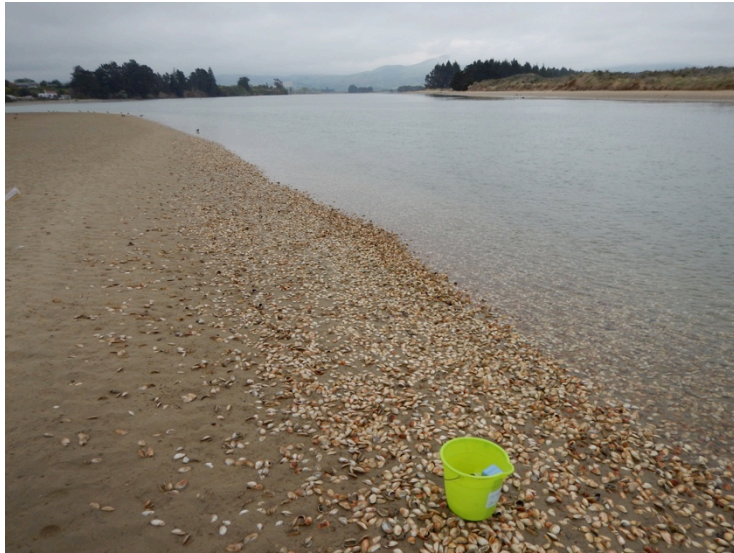
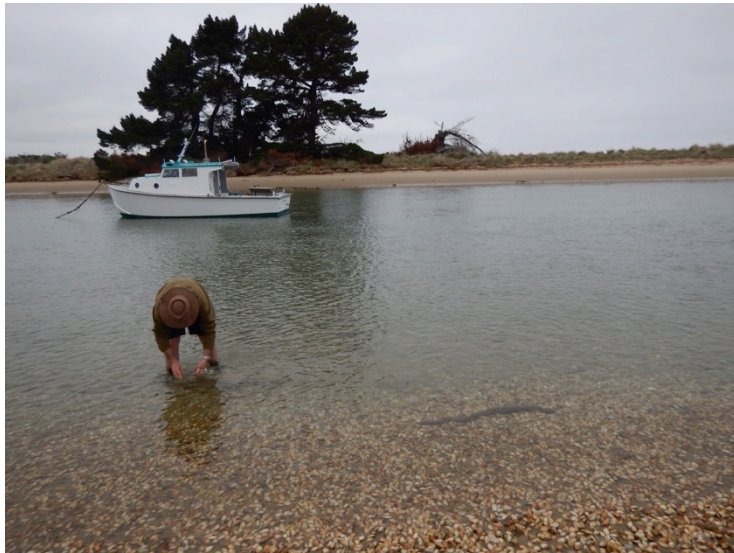
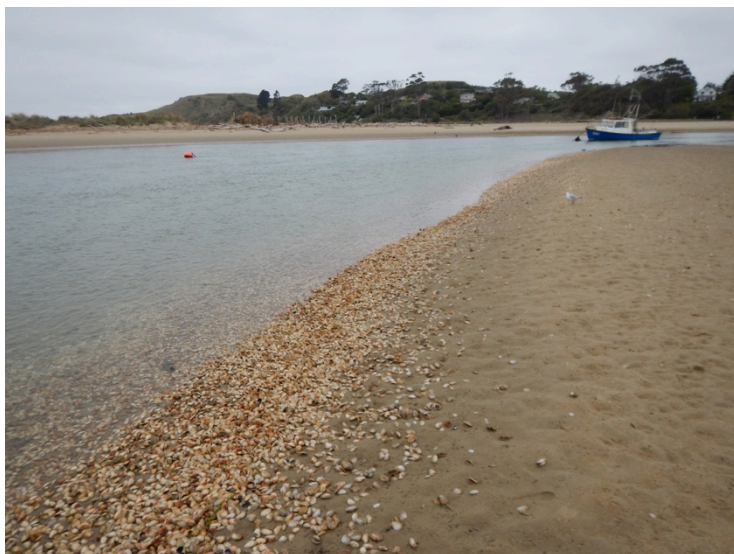
[0] Not Present
Site notes (Vegetation)	There was a sand dune on the true left of the site and a boat launching area and road on the true right.

Figure 14: Ohinepouwera (Site 8) showing an upstream (top), cross section (middle), and downstream (bottom) view.

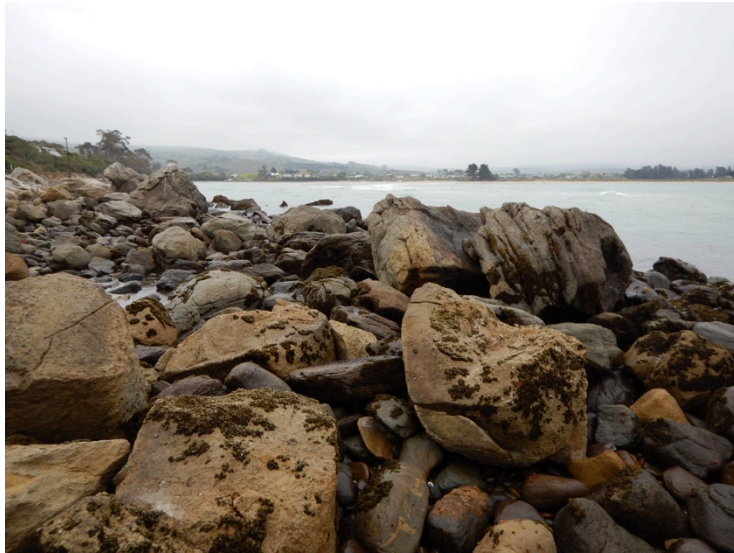
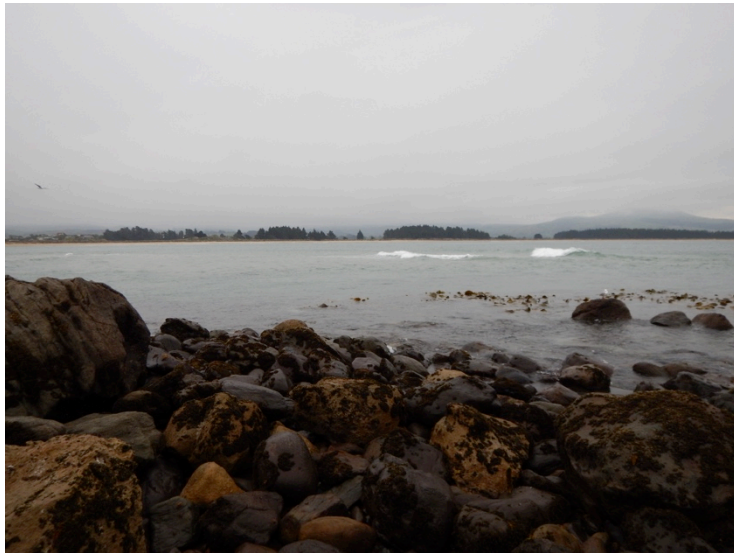
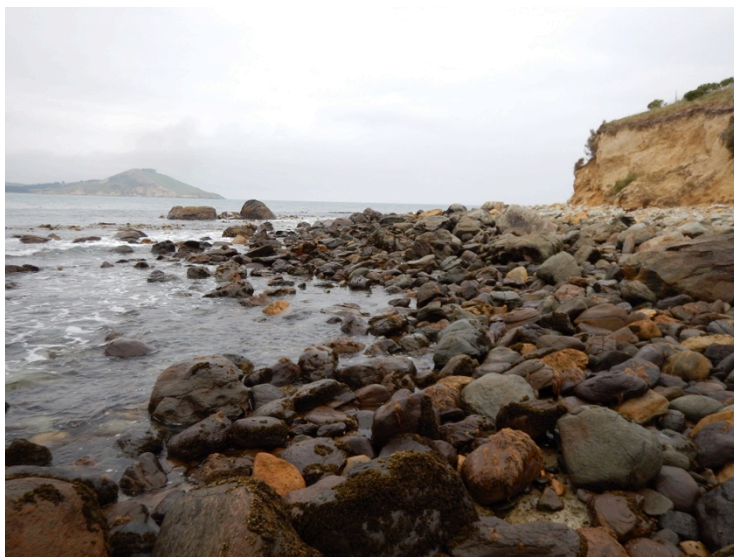
Huriawa was a marine site with influence from the Waikouaiti River. Physical characteristics and ecological information were not collected at this site.

Figure 15: Huriawa (Site 9) showing an upstream (top), cross section (middle), and downstream (bottom) view.

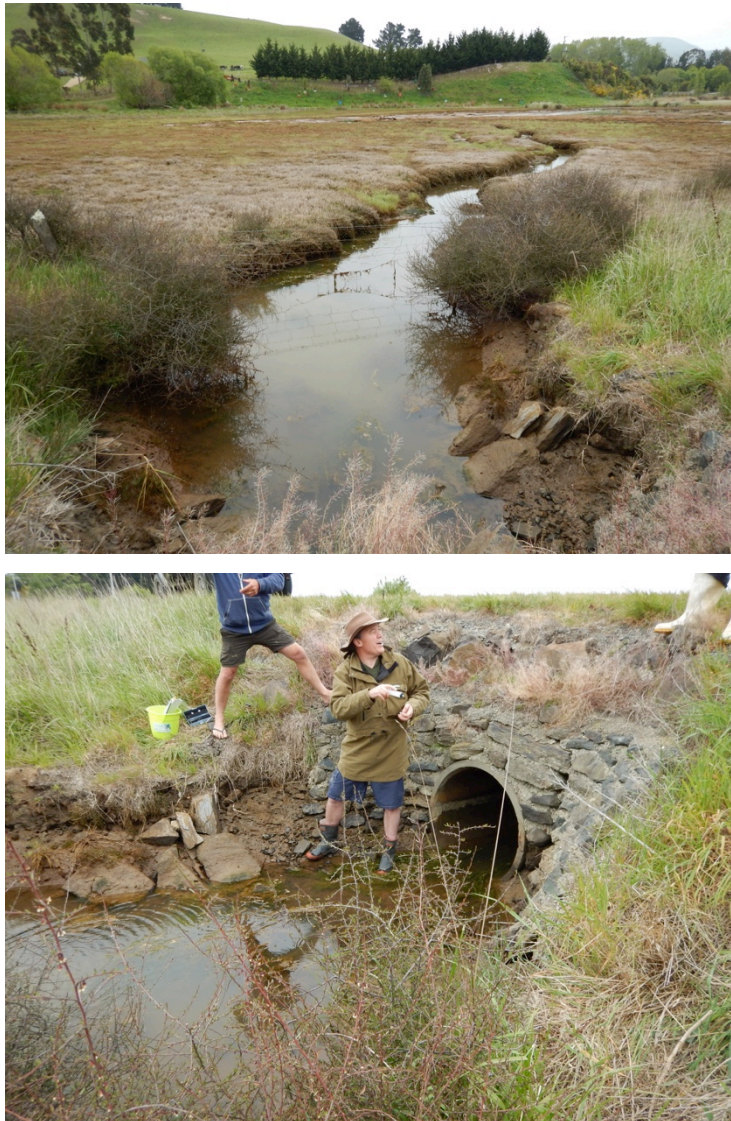
Figure 17: The Main Road (Site B) showing an upstream (top) and cross section (bottom) view.
